Wiss, Janney, Elstner Associates, Inc.
3609 South Wadsworth Boulevard, Suite 400
Lakewood, Colorado 80235
303.914.4300 tel
www.wje.com

Phase II Report - Geotechnical Subsurface Investigation

WJE No. 2022.4162

At your request and per our July 11, 2022, proposal, Wiss, Janney, Elstner Associates, Inc. (WJE) is pleased to deliver this report related to the geotechnical subsurface investigation of Mountain Recreation's Eagle Pool located at the above address in Eagle, Colorado.

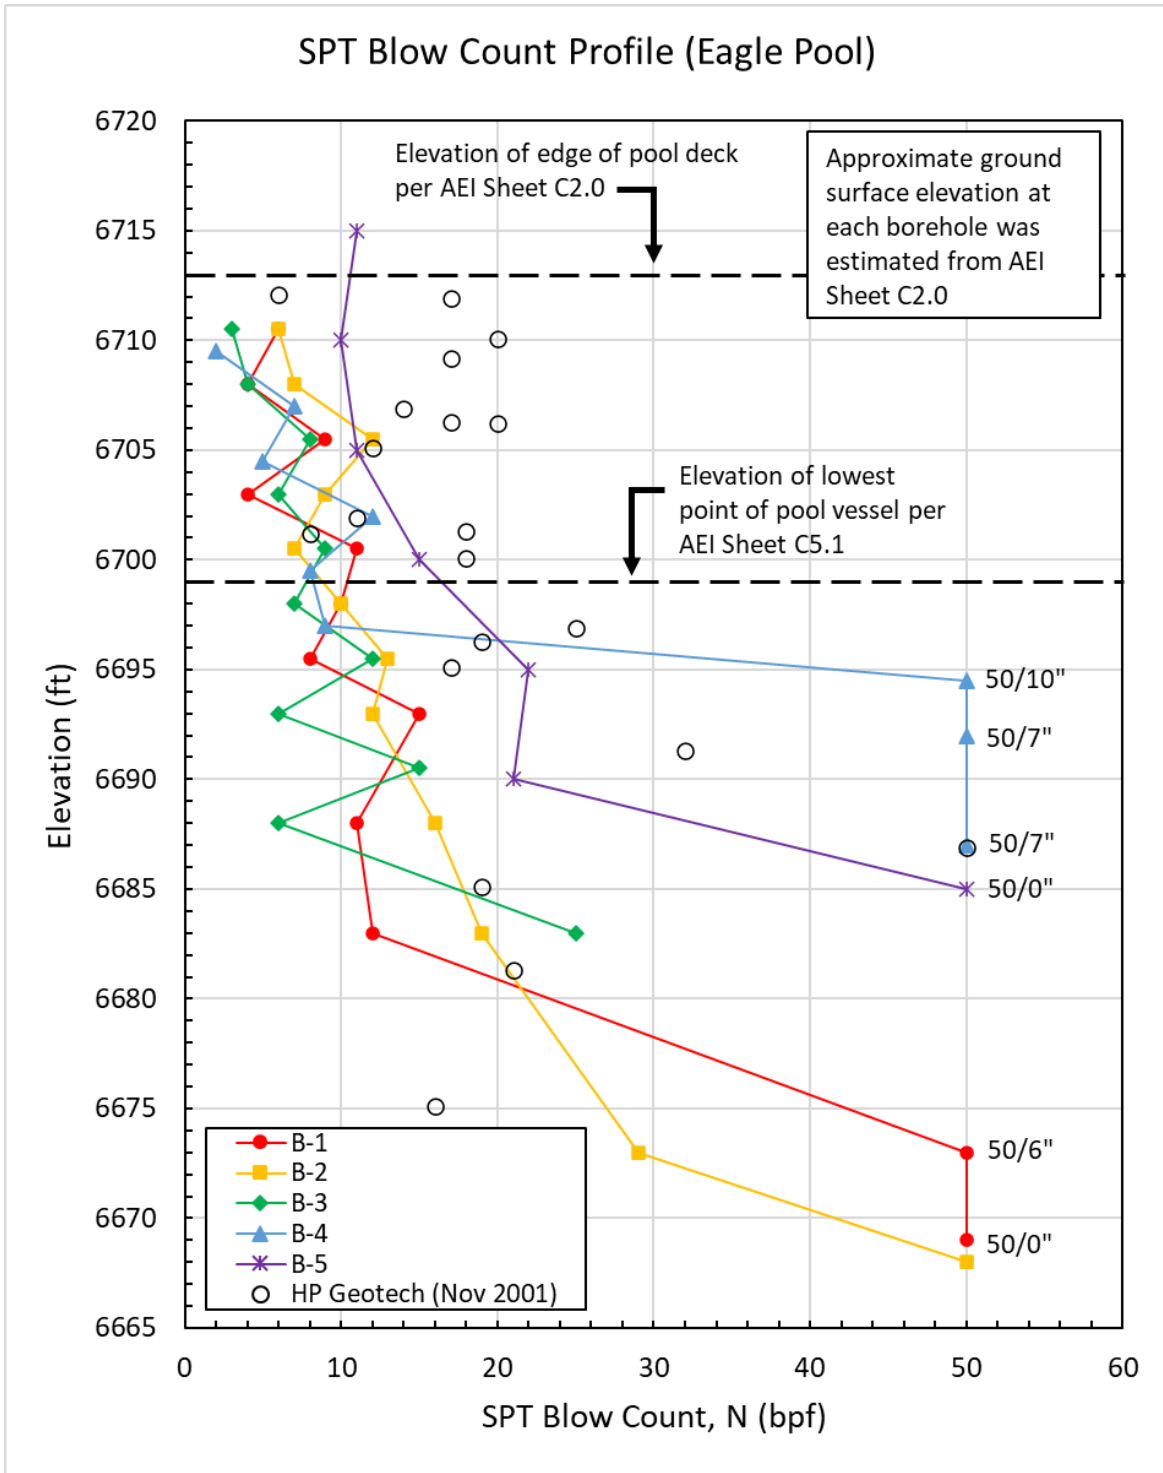
Figure 1. Subsurface Elevation Profile - Standard Penetration Test (SPT) Blow Count

2. As is apparent on Figure 1, SPT blow counts in our 2022 borings B-1 through B-4 are distinctly lower than our B-5, which was drilled outside of the pool area to the north, as well as the 2001 HP borings. This pronounced decrease in the SPT blow counts is consistent with collapsible soil behavior. These soils lose strength and volume when their moisture contents increase. The lower blow counts represent a significant loss of strength. This comparison of "before and after" blow counts indicates, in our opinion, that to some degree, the soil profile around and under the pool, as represented by borings B-1 through B-4, has indeed been subject to increased moisture content and collapse behavior.

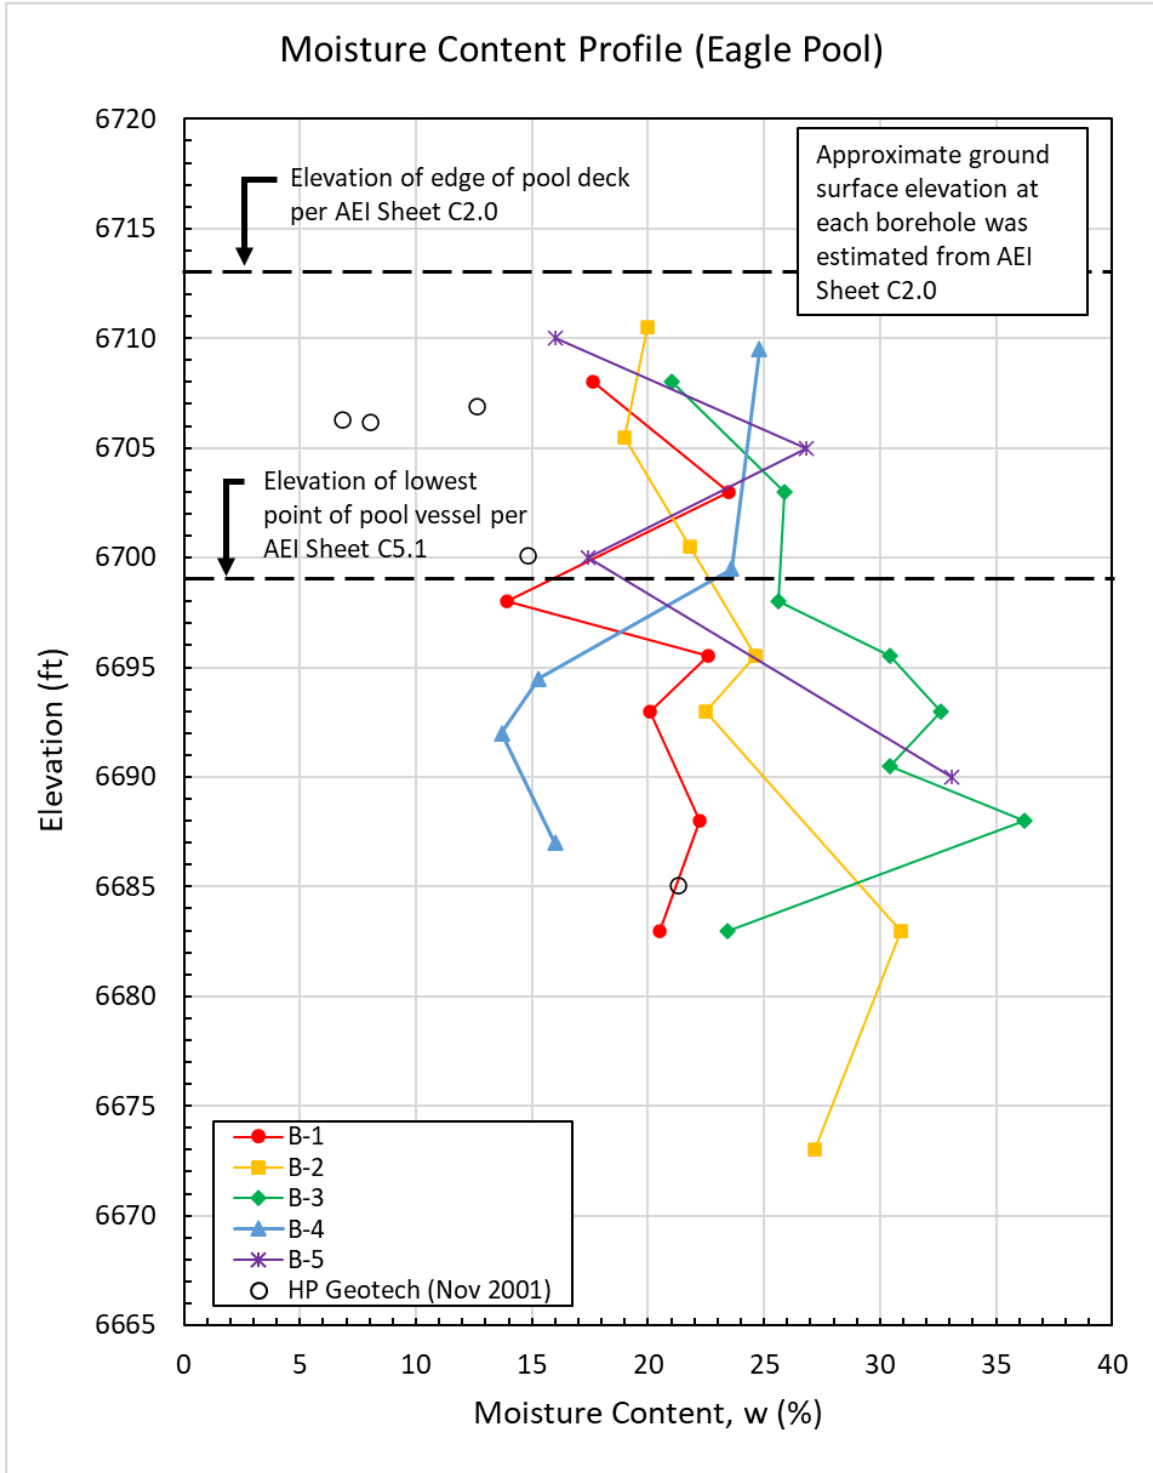
Figure 2. Subsurface Elevation Profile – Moisture Content

3. Figure 2, which depicts moisture content vs. elevation, also confirms that moisture contents have increased profoundly in and under the pool area in the roughly 21 years since HP's borings were drilled. Like Figure 1, this plot also confirms that the soil profile around and under the pool has been subject to moisture infiltration and collapsible soil behavior.

4. Figure 2 specifically indicates that boring B-3 exhibited significantly higher moisture contents, particularly at elevations below 6700 feet (the approximate bottom of the pool), than borings B1, B-2, and B-4. Note that B-3 was drilled at the corner of the pool that has settled the most, where the greatest pool leakage was observed (at TP-2), as discussed above.

5. In our opinion, it is not a coincidence that the wettest soil profile correlates very well with the location of the greatest pool leakage, as well as the lowest point of the pool perimeter (i.e., point of greatest settlement). The collapse behavior has progressed further at B-3 than at the other borings around the pool.

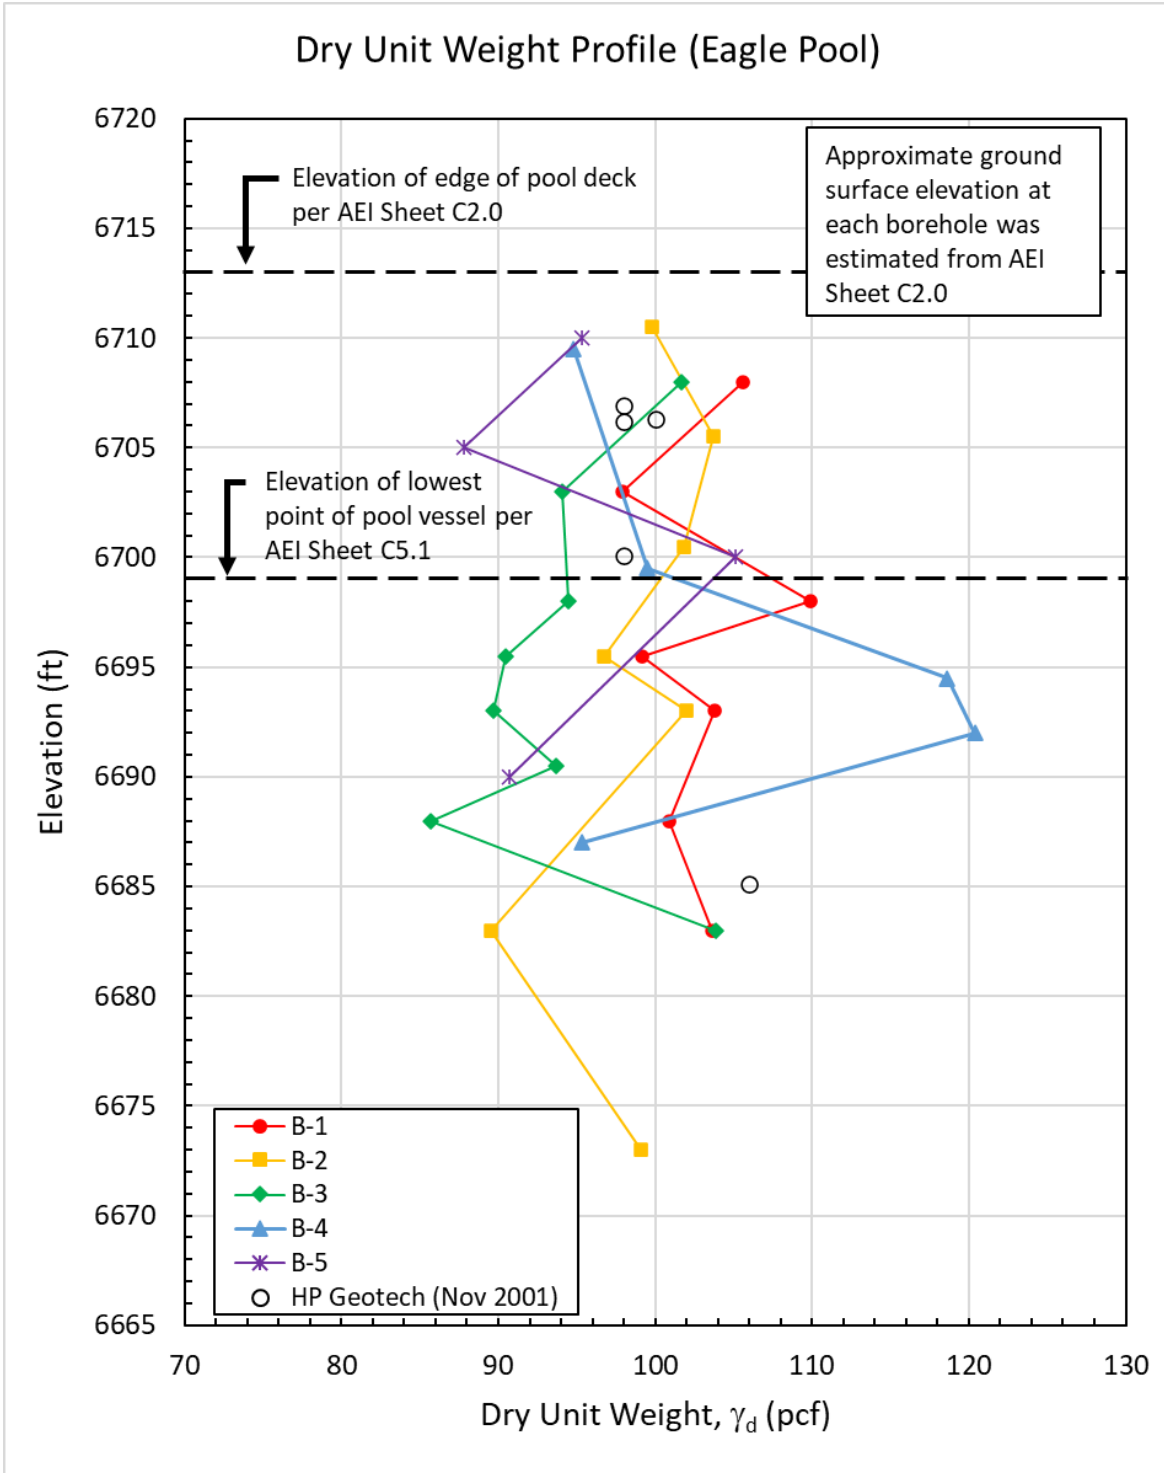
Figure 3. Subsurface Elevation Profile – Dry Unit Weight (Dry Density)

7. The plot of dry density vs. elevation (Figure 3) is less informing. The plot does not appreciably indicate a change in density from 2001 to 2022. One would expect dry density to increase as soil collapse occurs, but the plot does not particularly indicate this. We attribute this largely to sample disturbance. It is difficult to get truly undisturbed samples in collapsible soils (because they are collapsible), and so this particular plot is less informative. By contrast, the SPT blow count and moisture content plots are not affected by sample disturbance, and in this case are more informative.
