Wiss, Janney, Elstner Associates, Inc.
3609 South Wadsworth Boulevard, Suite 400
Lakewood, Colorado 80235
303.914.4300 tel
www.wje.com

Phase II Report - Geotechnical Subsurface Investigation

WJE No. 2022.4162

At your request and per our July 11, 2022, proposal, Wiss, Janney, Elstner Associates, Inc. (WJE) is pleased to deliver this report related to the geotechnical subsurface investigation of Mountain Recreation's Eagle Pool located at the above address in Eagle, Colorado.

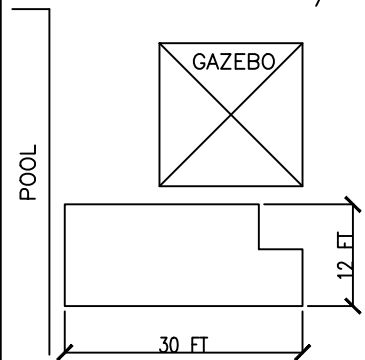
SANDY SILT, moist, tan and brown with trace calcareous nodules

Pool supply and return lines were exposed in this pit; returned on morning of 7/14/2022 to inspect for leaks; none observed

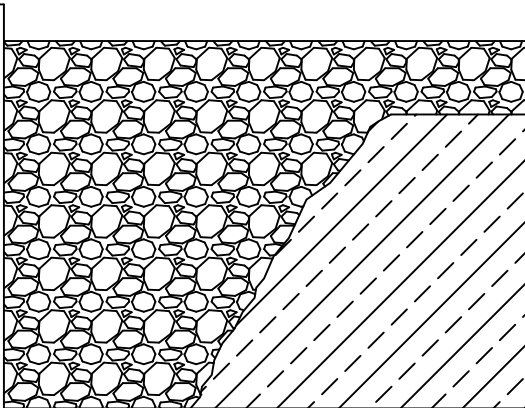
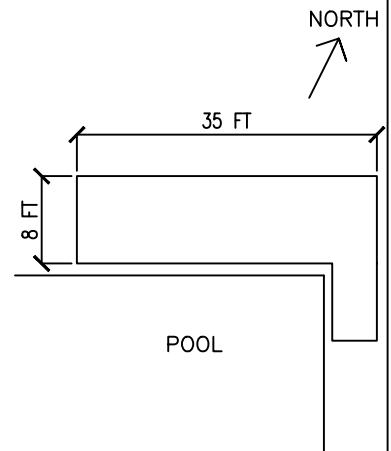
Bottom of test pit at 5.5 feet below the top of the concrete pool deck.

Concrete pool deck 3-5 inches thick
GRAVEL base, with silt, wet, grey
SANDY SILT, moist, tan and brown

Concrete pool deck removed on 7/13/2022 (7-8 am)
Soil wetter near east end of excavation by NW corner of pool
Extended pit around NW corner of pool after observed water running down pool wall and a cavity/void under pool deck near NW corner
Pool supply and return lines were exposed in this pit; returned on morning of 7/14/2022 to inspect for leaks; none observed

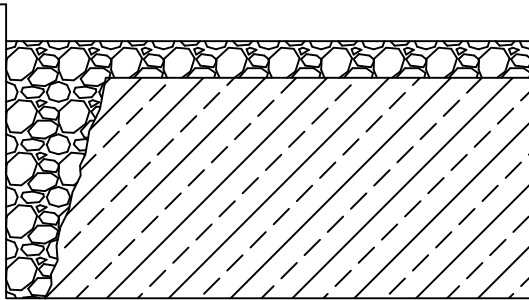
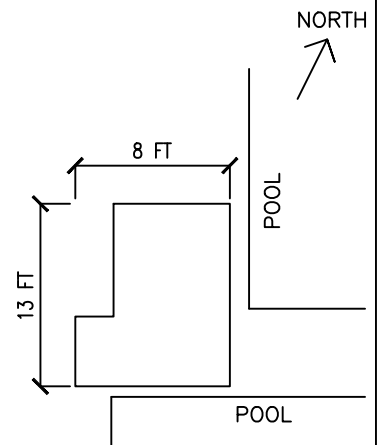
Concrete pool deck 3–5 inches thick

SANDY SILT, moist, tan and brown

Multiple water leaks at joint between gutter and concrete pool wall

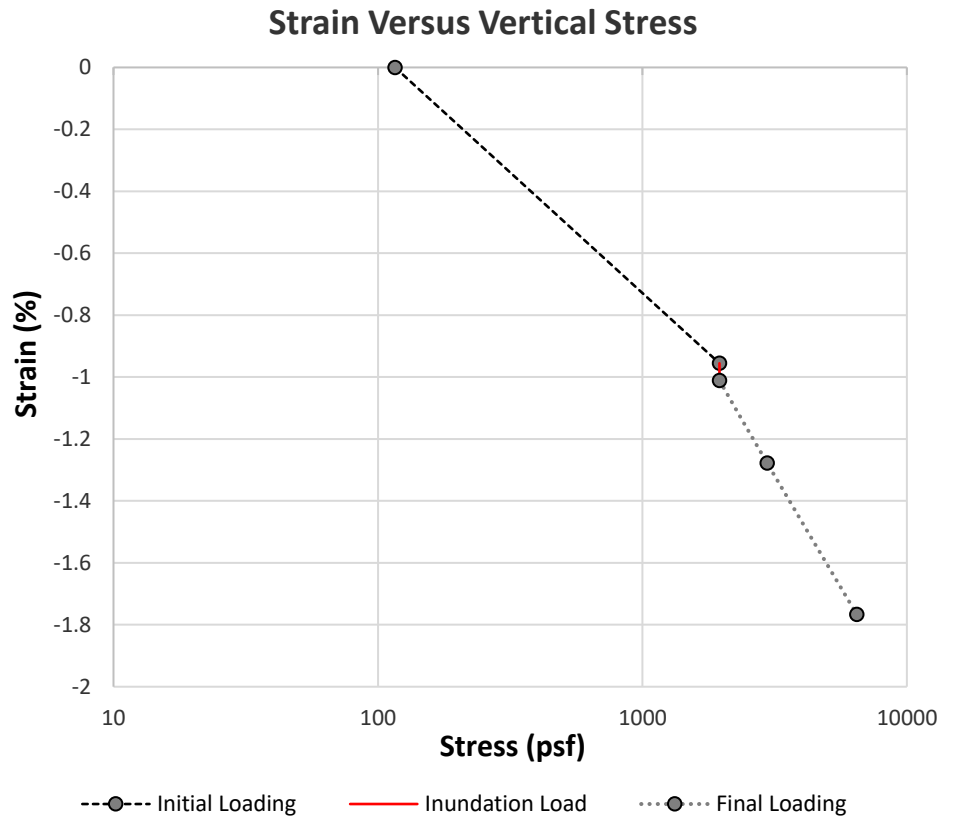
Collapse (%): -0.06	Swell Pressure (psf): --
	Swell Pressure (kPa): --

Load (psf)	Deformation (in)	Strain (%)
116	0.0000	0.00
1956	-0.0086	-0.96
Inundated	-0.0091	-1.01
2962	-0.0115	-1.28
6465	-0.0159	-1.77

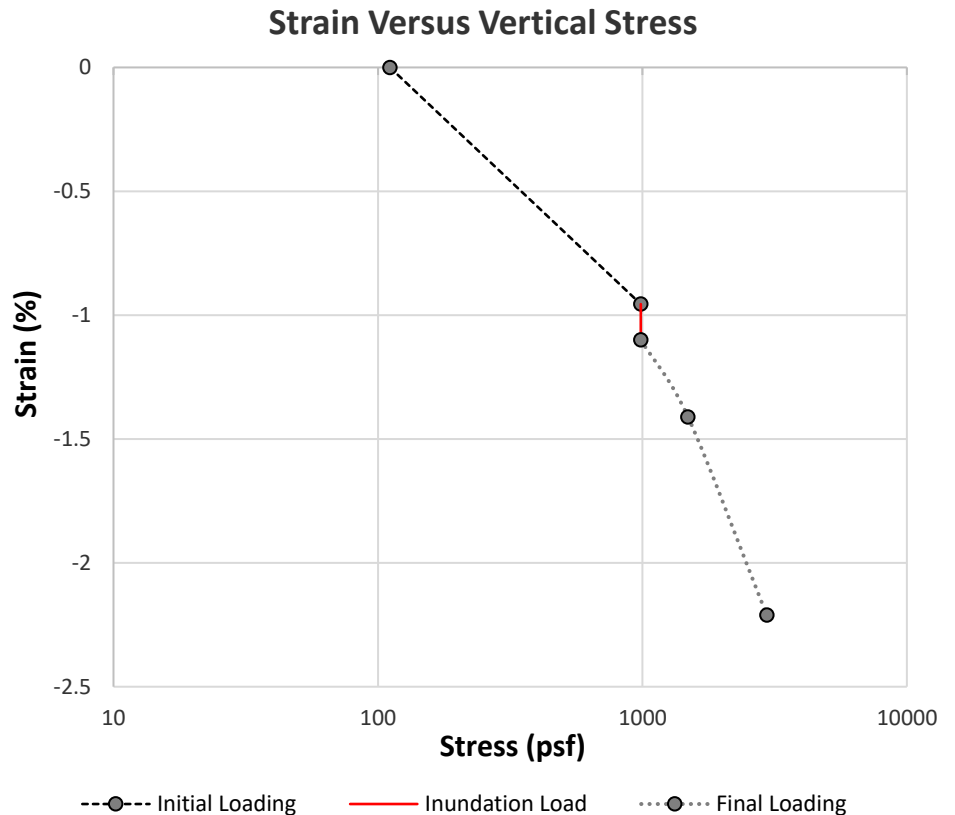
Collapse (%): -0.14	Swell Pressure (psf): --
	Swell Pressure (kPa): --

Load (psf)	Deformation (in)	Strain (%)
111	0.0000	0.00
986	-0.0086	-0.96
Inundated	-0.0099	-1.10
1487	-0.0127	-1.41
2952	-0.0199	-2.21

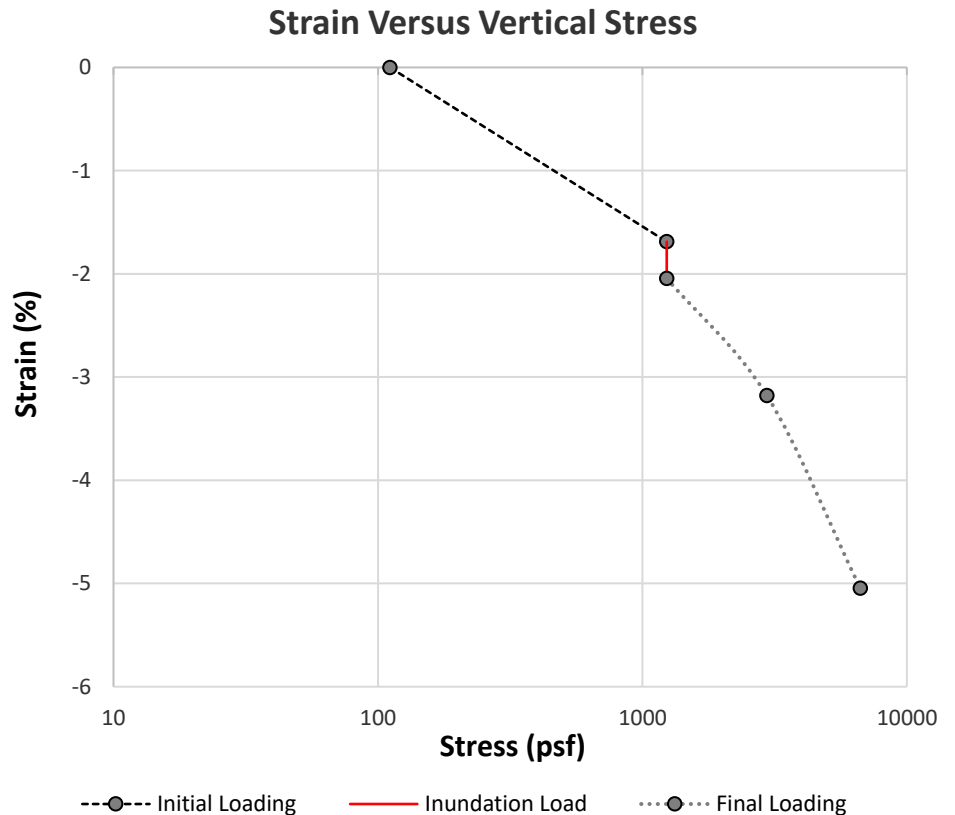
Collapse (%): -0.36	Swell Pressure (psf): --
	Swell Pressure (kPa): --

Load (psf)	Deformation (in)	Strain (%)
111	0.0000	0.00
1236	-0.0152	-1.69
Inundated	-0.0184	-2.04
2952	-0.0286	-3.18
6659	-0.0454	-5.04
